## Mold Contamination in Fiberglass in Insulation

### Cause & Detection of Mold Contamination in Fiberglass Insulation in Buildings

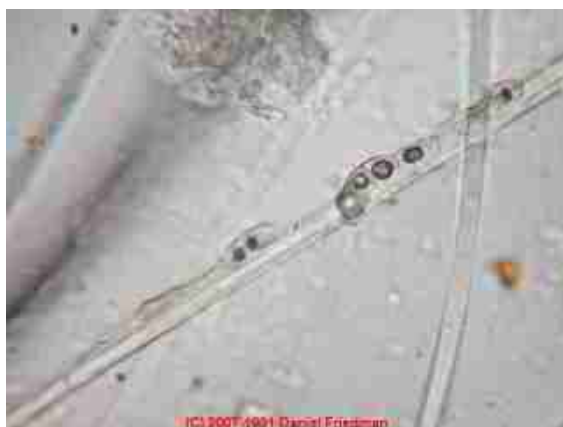
The 720x photographs above and just below show active fungal growth along the surface of a fiberglass insulation fiber collected the suspended ceiling of a building suffering wet conditions and moldy in-slab HVAC ducts.

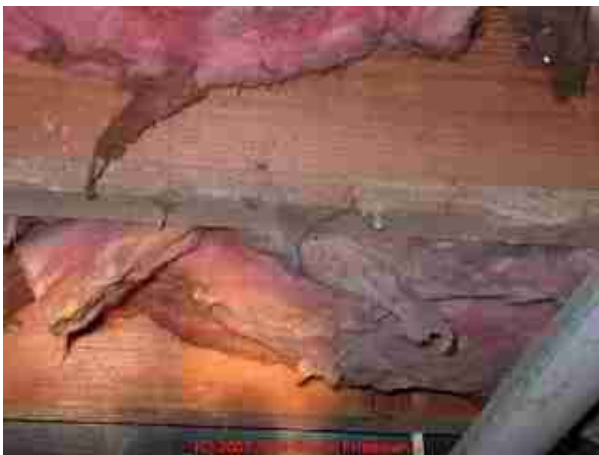
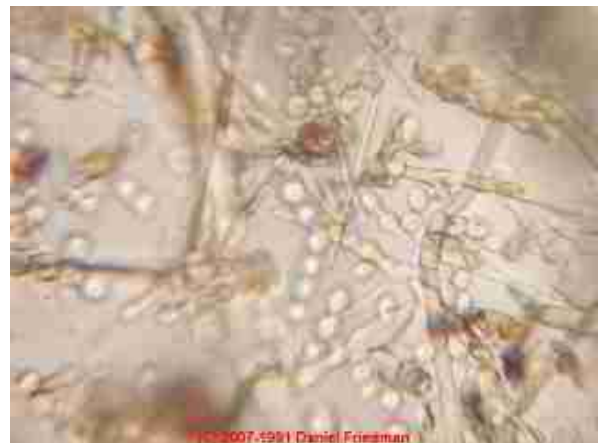
Except for some superficial "dust staining" that is often simply thermal tracking by house dust, the pink fiberglass insulation shown below (left) looked clean. Unlike our black insulation mold photo above, there was no visible mold on the pink fiberglass insulation shown (below left).

But vacuuming the center (most clean-looking area) of that mold and lab examination of the vacuum dust sample contents showed the long *Penicillium/Aspergillus* spore chains (below right) consistent with local problematic mold growth.

Recapping, the pair of photographs (above) shows fairly clean-looking fiberglass insulation over a crawl space which in fact had been subjected to flooding. While the insulation itself did not appear to have been flooded, and while there was no mold visible on or in this fiberglass insulation, a simple vacuum test demonstrated that the insulation was severely contaminated with *Aspergillus sp.* mold.

The presence of both mold spore chains and conidiophores of *Aspergillus sp.* in the insulation test samples whose photos are shown above confirmed that not only was the crawl space ceiling fiberglass insulation moldy, but it was supporting active fungal growth.

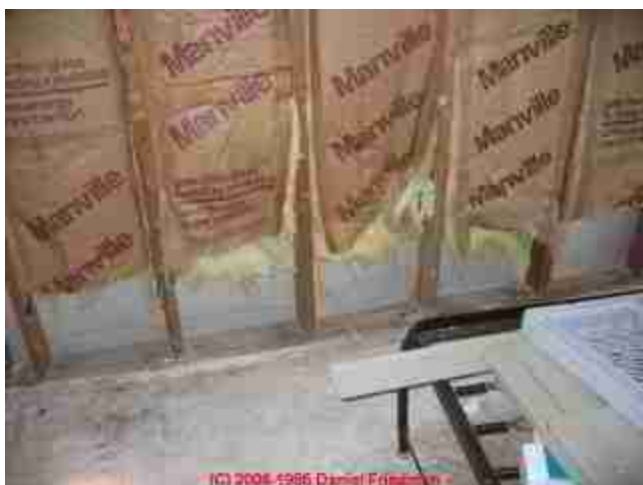
In the partially-opened basement wall shown here, the water track stains on the cavity side of the exposed drywall (shown after a test cut was made) indicate that water passed in this wall from above.

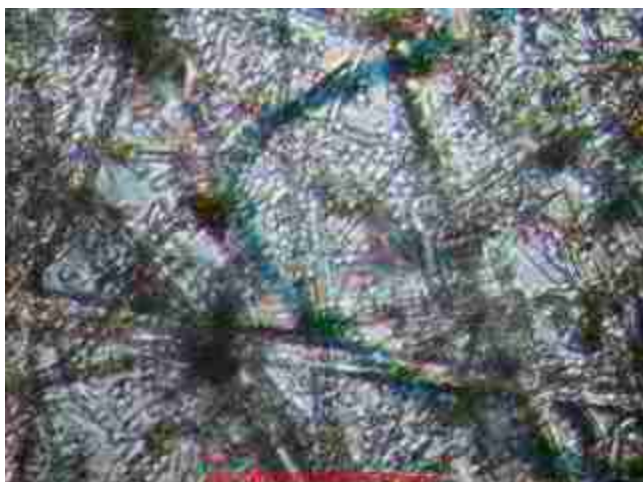
The photo at above right shows a very dense presence of *Pen/Asp* spores and spore chains as well as a portion of a conidiophore (lower left) in this insulation test sample, indicating that mold appeared to be growing in the insulation, not simply accumulated there from another building mold reservoir.

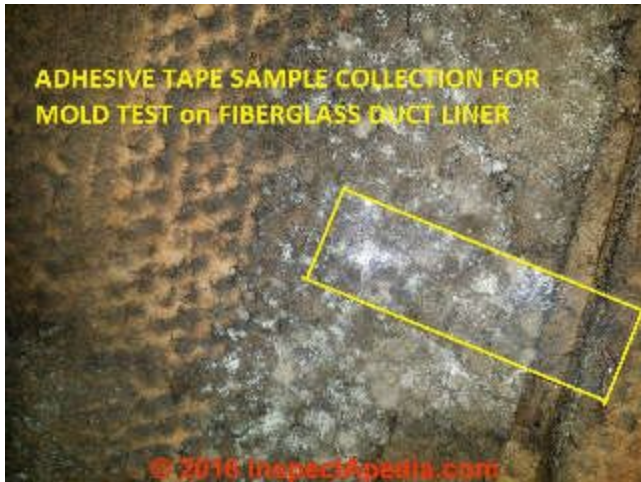
Above: white "growth" found on the interior surface of fiberglass-lined HVAC ducts in a home in Atlanta, GA in 2016. Look closely to see the presence of clear adhesive tape being used to collect a sample from this surface to permit laboratory analysis.

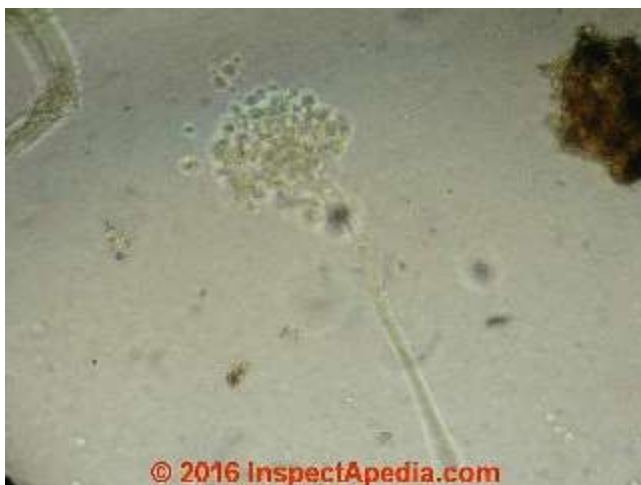
Above first photo, sample 2, *Aspergillus* sp. conidiophore and hyphae at upper left, *Penicillium* conidiophore at lower right.

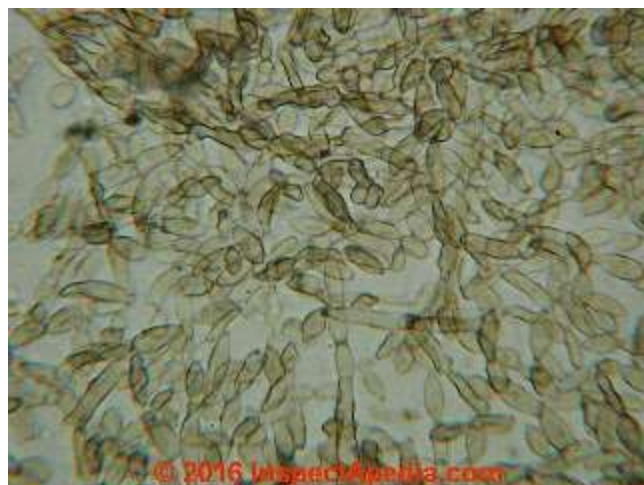
Above second photo sample 2, *Cladorporium* sp. in dense fungal growth on the surface.

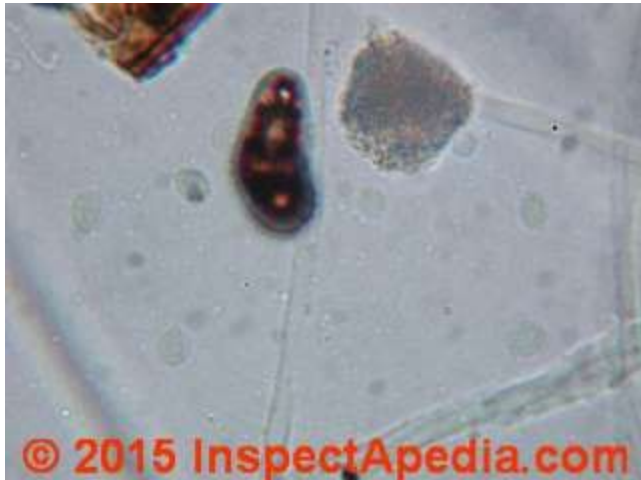
Just below is an individual *Curvularia*-like mold spore to the left of what is probably a fragment of gypsum or drywall material.

More subtle in this photo are individual *Penicillium/Aspergillus* mold spores. Small and colorless these are harder to see unless the microscopist takes care and time. The combination of these particles in a vacuum sample of fiberglass insulation suggests that this insulation became contaminated by airborne debris, perhaps during demolition of moldy drywall.

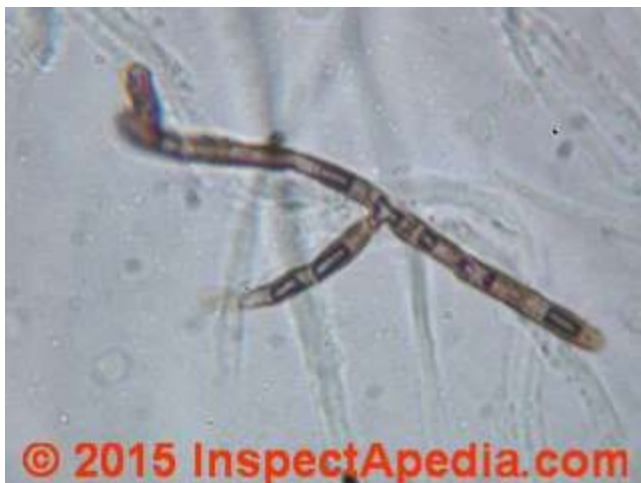
Below is a large hyphal fragment in fiberglass insulation; from this observation we can be confident that wet conditions and growing mold have been present in the building where this sample was collected. The image does not mean that this fungus was necessarily growing in or on the fiberglass itself.

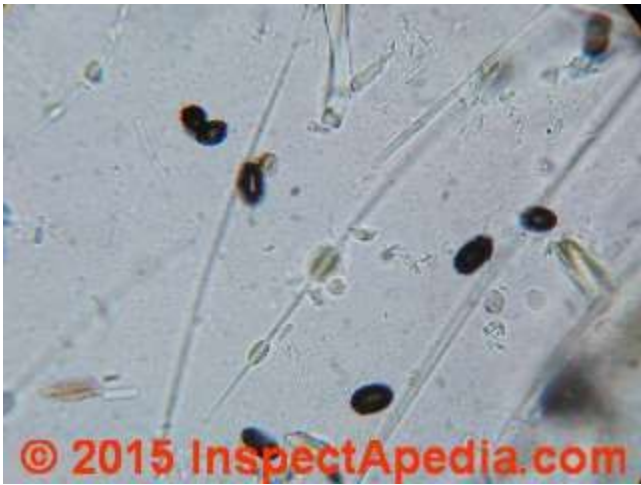
Below are multiple *Stachybotrys chartarum* mold spores in a fiberglass insulation sample and in the background I see some colorless Pen/Asp spores as well. This sample strongly suggests that there has been demolition of moldy materials, probably drywall, in the area where this fiberglass was exposed.

There is no evidence that these fungi are growing on or in this particular insulation sample. Any thick fibrous material can collect airborne particles and can be difficult or impossible to clean completely. This fiberglass insulation should be discarded.

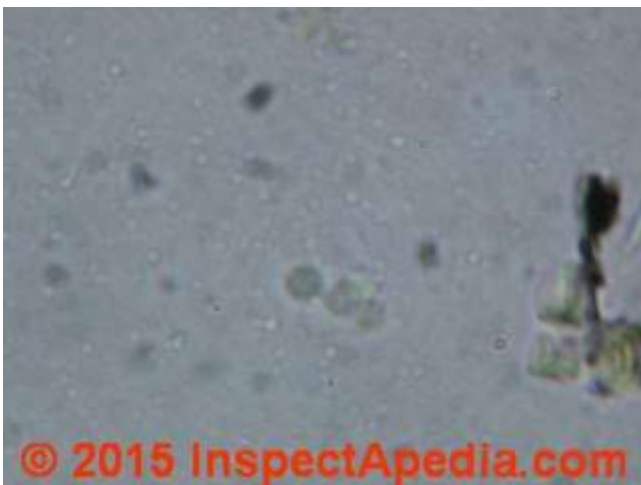
Below my photo illustrates a short three-spore chain of *Penicillium* or *Aspergillus* mold spores. These fungal contaminants are a particular concern because their small size (often in the 1u range) means they can be inhaled deeply into the lungs.

Because these spore chains are very fragile and break into individual spores quickly when airborne, when we find a spore chain of *Penicillium* or *Aspergillus* mold in an environmental sample I am confident that there has been or is currently nearby active growth of one or both of these mold genera/species.
