## Mold Contamination in Fiberglass in Insulation

### Cause & Detection of Mold Contamination in Fiberglass Insulation in Buildings

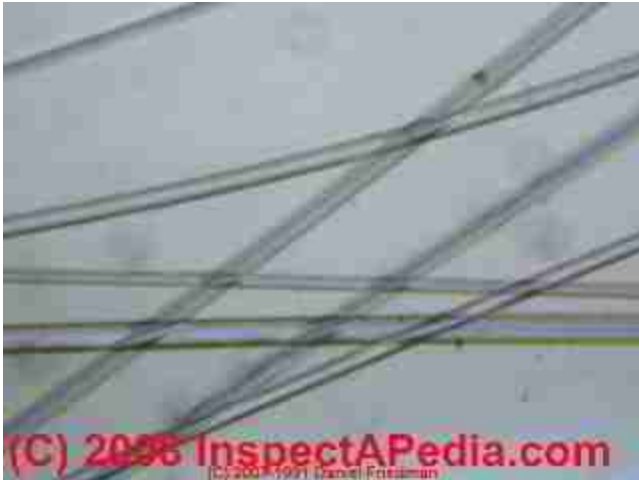
What can be tricky in investigations of mold contamination in building insulation is that severely mold-contaminated fiberglass insulation may look pretty clean to the naked eye.
